# Water quality and sanitation in rural Moldova

## ABSTRACT

The aim of the project is to do an assessment of the drinking water quality as well as the sanitation situation in the village Condrita in the Republic of Moldova. This was done by studying the existing water and sanitation facilities, sampling the water, evaluating the reason for the poor water quality and mapping the current situation using ArcGIS. Furthermore, technologies for improving the drinking water and sanitation facilities are suggested.

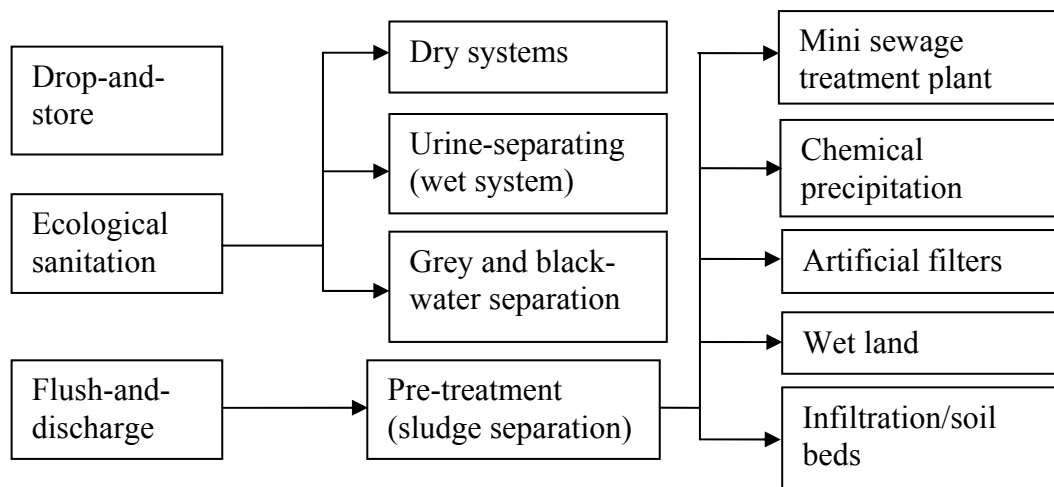
**Figure 6** Small-scale solutions for sewage treatment (modified from Palm et al. 2003).

divided into further subgroups (figure 6). In order to choose a suitable technology for rural developing areas several aspects need to be considered, including health, environmental resources, technology, financial and socio-cultural.

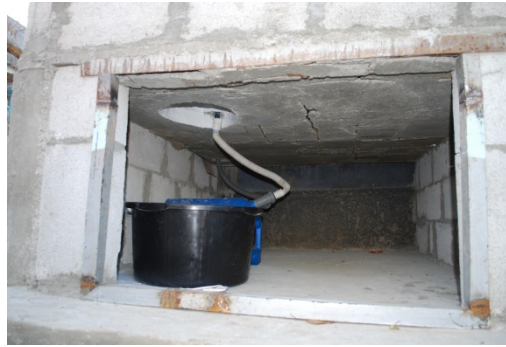
**Figure 11** Compartment underneath the toilet. Urine is collected in the tank connected to the hose and faeces in the black container (photo by Katja Larnholt).

An ecosan toilet from one of Wisdoms pilot projects is displayed in figures 10-13, where the ecosan toilet building was attached to the main house (figure 10). On the right hand side of the house one can see the ventilation pipe that removes odour from the compartment where urine and faeces are collected. A closer view of this compartment can be seen in figure 11 where the blue tank at the back collects urine, while faeces are collected in the black container. When the black container is full it can be shoved to the back of the compartment where decomposition can be completed. Figure 12 displays a urine separation toilet seat in Styrofoam and figure 13 a ceramic urinal.

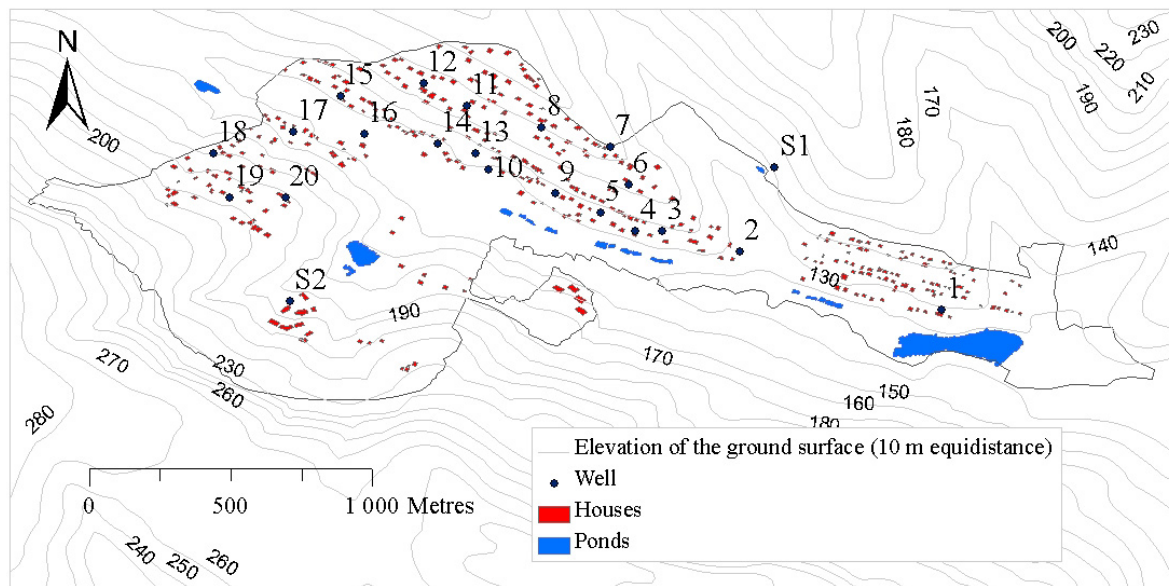
Figure 17 Topography in the study area (altitudes in m. a. s. l.).

The elevation in Condrita varies between 130 and 230 m above sea level (figure 17). There are no natural watercourses in the area; however, there are a few artificial ponds as displayed in figure 17. Through the lowland areas in Condrita there is a concrete drainage channel, which is partly represented by the smaller areas of water in the vicinity of wells 9, 5, 4 and 3. Surface water will runoff to this drainage channel and be lead to the larger pond in the south-eastern part. There is no open outflow from the pond, i.e. either the water infiltrates or evaporates. Some of the water is used for irrigation. The catchment area for Condrita is displayed in figure 18.

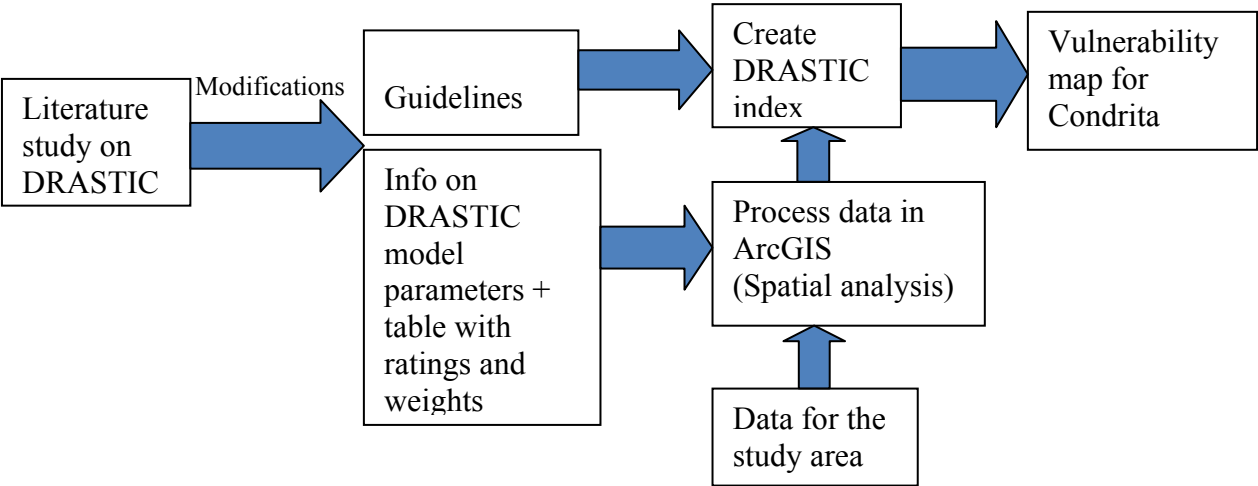
Figure 19 Schematic description on how the work with the DRASTIC model was done.

In order to locate areas in Condrita that are more vulnerable to groundwater contamination than others, a vulnerability assessment was performed using the DRASTIC model. A literature study on the model was initially performed, which gave guidelines on how to carry out the modelling. Model data were retrieved during the field study and processed according to the guidelines. Some modifications were at first made on the model to fit the study area. The model resulted in a calculated DRASTIC index, which indicated where vulnerability was low, moderate and high in Condrita. Model procedure is schematically described in figure 19. The guidelines are described in more detail in appendix D, which also gives information on how data were processed in ArcGIS.

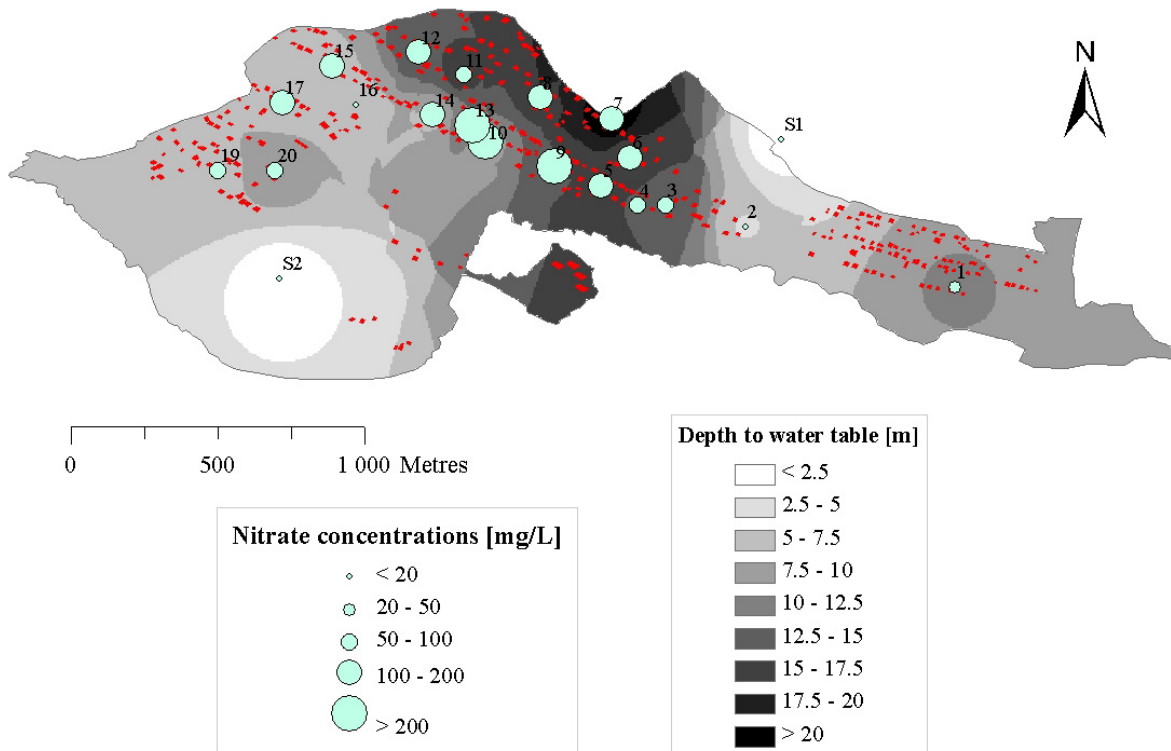
**Figure 23** Depths to the water table and sampled nitrate concentrations in the wells.

water table smaller than 20 m. Furthermore, little correlation between water depths and the levels of nitrate concentrations were found. The interpolation is probably not accurate in the western part of the village due to the few points of data in this area. The area with shallow groundwater surrounding spring S2 is possibly larger in figure 23 than in reality.

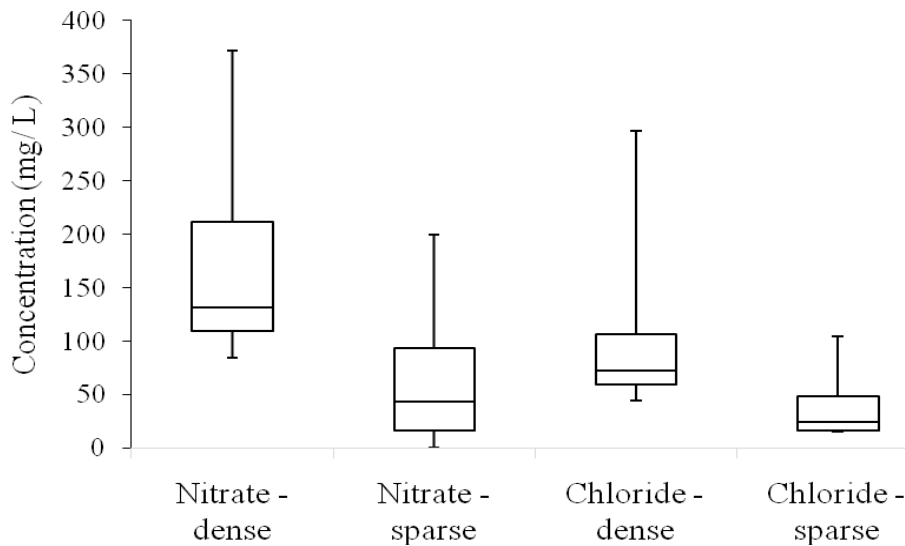
**Figure 25** Distribution of data for nitrate and chloride in the densely and sparsely populated parts of Condrira.

To show the distribution of data between the densely and sparsely populated parts of the village, box plots were created. In the plot, the box represents the two middle quartiles in the interval of measured values and the horizontal line inside the box indicates the median value. The vertical lines outside the box represent the lower and upper quartile of the measured values within the data interval. Figure 25 shows that median values were higher for both nitrate and chloride in the densely populated part of Condrita. In all cases, measurement values above the median varied more than below the median value. In the dense part of the village all nitrate measurement values exceeded the WHO guideline of 50 mg/L.

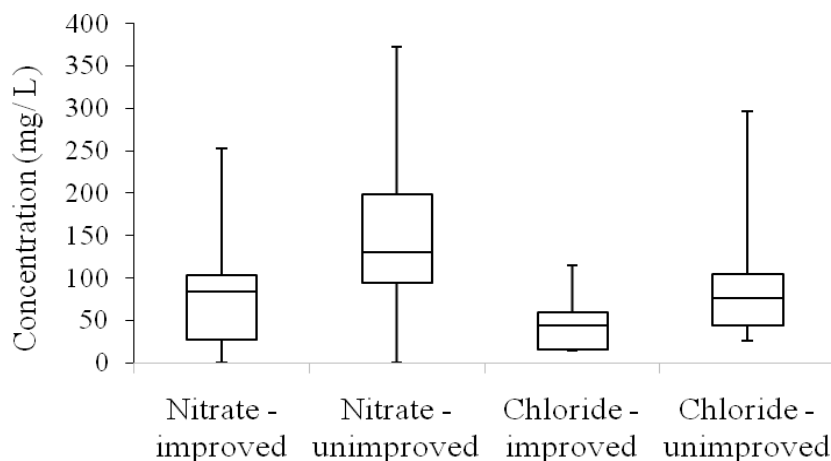
**Figure 27** Distribution of data for nitrate and chloride in improved and unimproved water sources.

Wells 1, 3-7, 11-13, 16, 18, 19 and the monastery spring (S2) were defined as improved water sources, while remaining wells and the forest spring (S1) were considered as unimproved (section 5.1.1). It was found that the median values for both nitrate and chloride were higher for unimproved sources. The minimum concentrations for each substance were quite similar for both improved and unimproved sources, but the maximum values were higher in the unimproved water sources (figure 27).

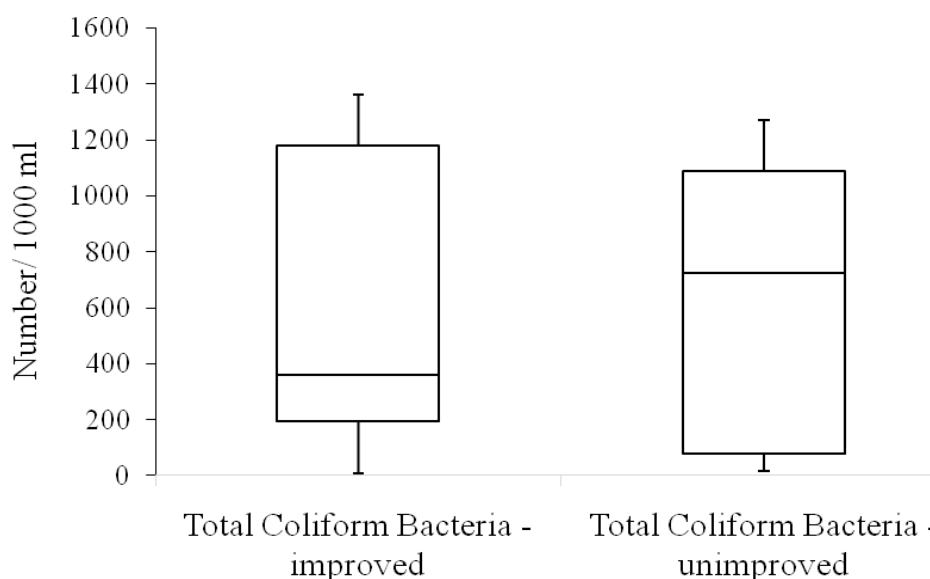
**Figure 28** Distribution of total coliform bacteria in improved and unimproved water sources.

When it comes to total coliform bacteria, the data range was almost the same for both types of water sources. Of the recorded values, 50 % occurred in the lower fourth of the data range for improved water sources. Almost the opposite situation was found for unimproved constructions (figure 28).

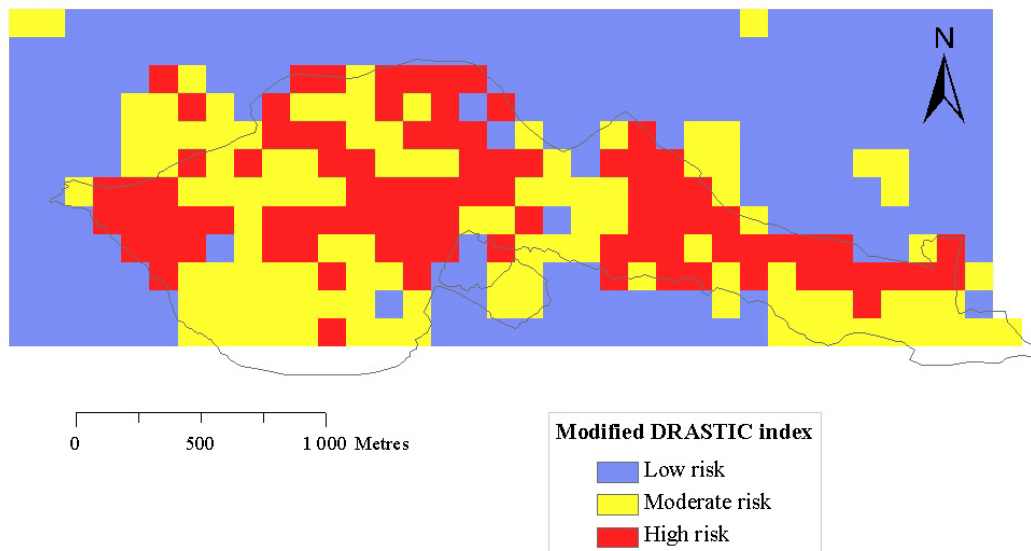
**Figure 35** Calculated modified DRASTIC index for the study area.

The DRASTIC model calculations gave a modified DRASTIC index that ranged from 108 to 152 (theoretical minimum value was 101 and maximum was 163). The DRASTIC index was divided into 3 classes and reclassified as low (108 to 123), moderate (123 to 131) as well as high (132 to 152) risk areas respectively (figure 35). Low risk areas were mostly found in the forest that surrounded the municipality, while most of the village area was more or less equally covered by moderate and high risk areas.

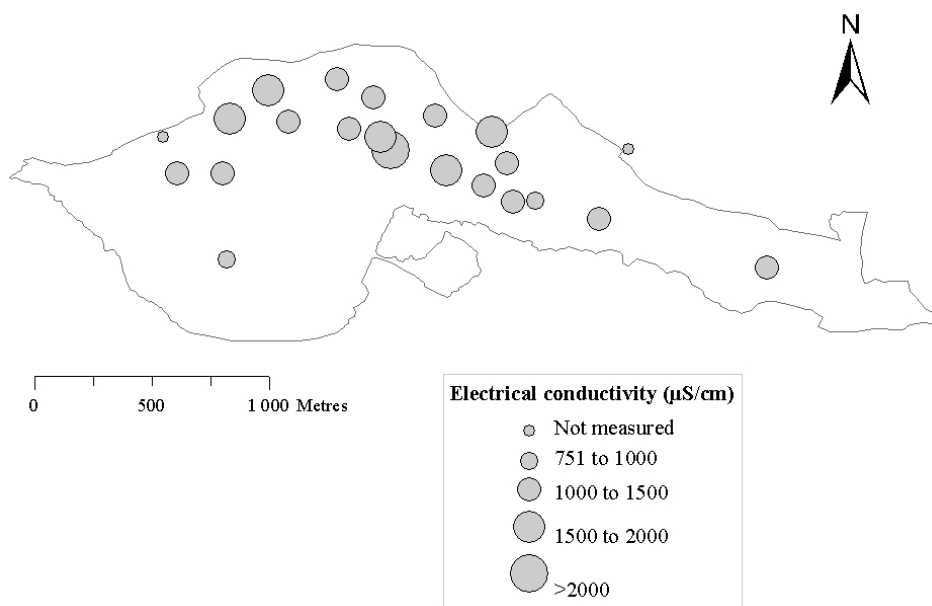
Figure C2 Electrical conductivity measurements in the study area.

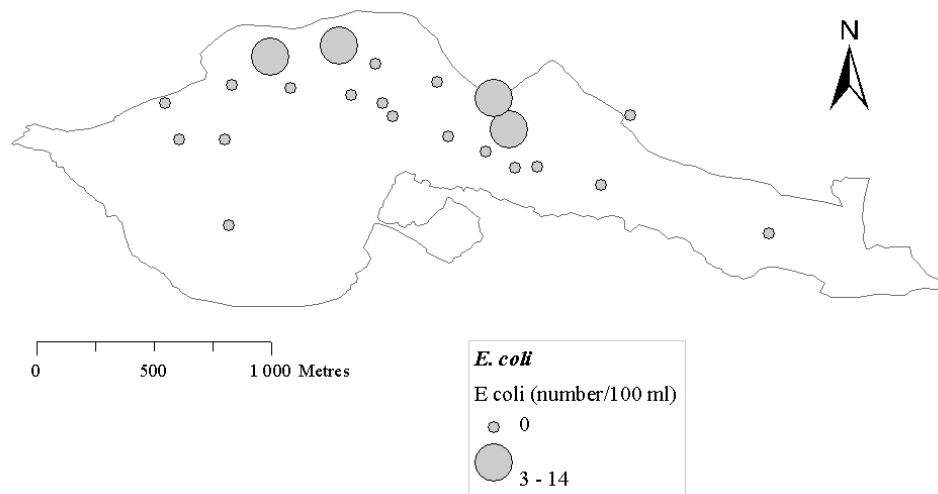
**Figure C4** *E. coli* bacteria in the study area.

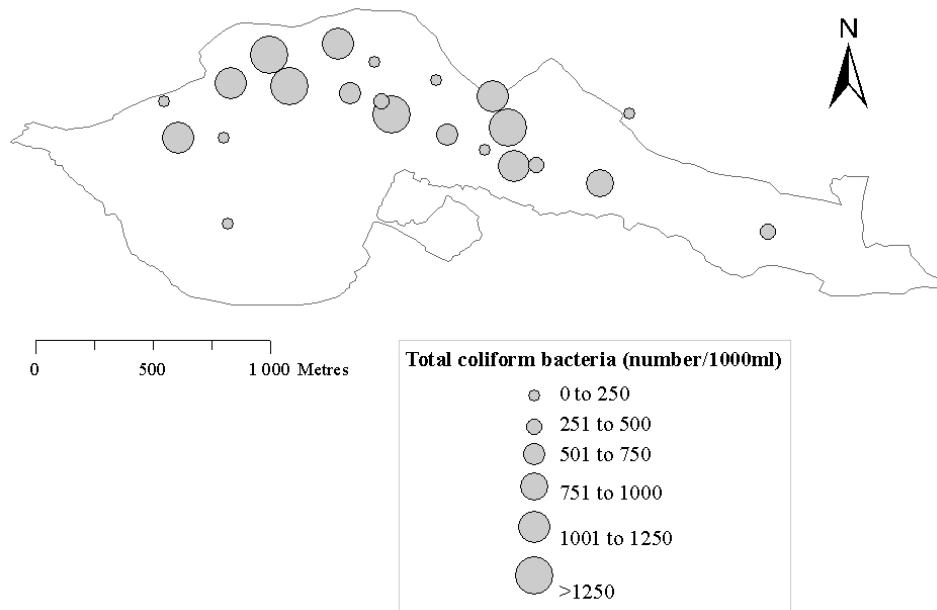
**Figure C5** Concentrations of total coliform bacteria in the study area.

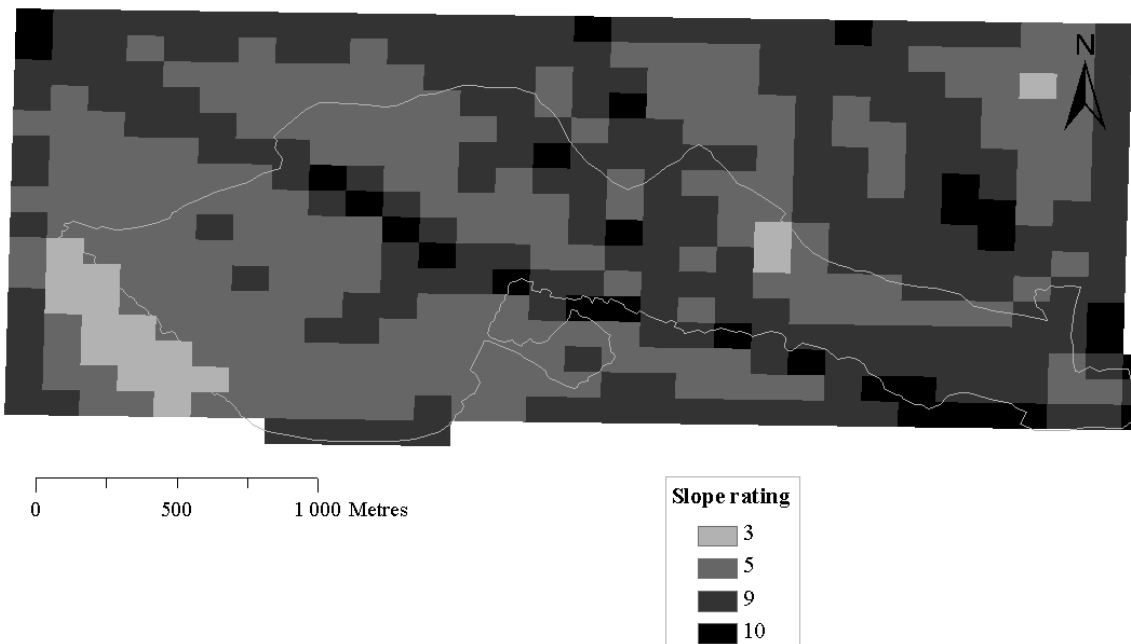
**Figure D3** Rating of T – Topography. The fifth DRASTIC parameter, which describes what influence slope variation (in per cent) has on potential ground water contamination.
